Motor Coupled Leica 250 Survey

Jim Lager

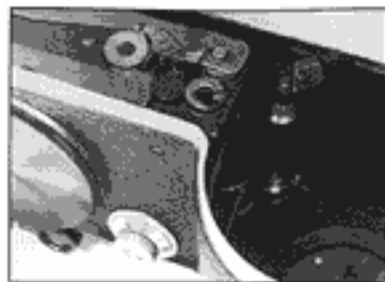
Fig. 5. Ramp type coupling and transverse spring on Leica Reporter No. 352653. Also, note film tensioning roller.

The most commonly seen coupling is the ramp type illustrated in Figure 5 with the sloping surface of the coupling and the transverse spring being clearly visible. Figure 6 shows Leica Motor 10038 with ramp type drive dog and pull-down claw; this motor, matched to Reporter No. 352412 was delivered to Berlin on the 10th December 1941. The chart below shows details
